5TH TANK DESTROYER GROUP APO 758, U.S. ARMY

15 December 1944

MEMORANDUM:

1. To ascertain from first hand observation the effect of bazooka fire on the Mk V, Panther tank, sixteen rounds were fired at a knocked out 130 Pz Lehr Mk V, which had been immobilized by the 776 TD Bn's 90mm fire.

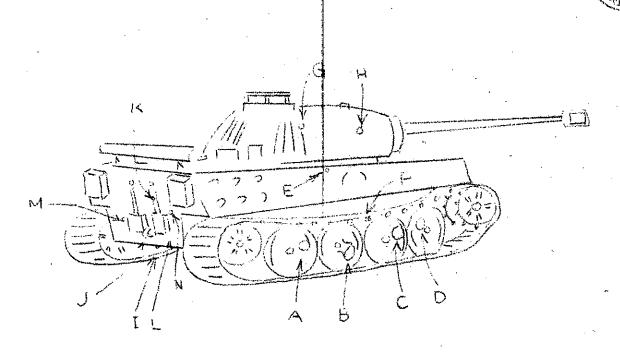
2. Diagram of tank indicating location of hits:

Description of Hits

a. Ricochet into wheel rim completely severing the tire and blasting an 8 " hole in the wheel. There was no damaging effect upon the inner wheel immediately behind the one hit.

<u>b.</u> Direct hit upon a wheel. A $3 \ge 5^{\circ}$ hole was blasted out of the wheel and two 10 " radial cracks were made. There was no damaging effect upon the wheel immediately inside the one hit.

<u>c & d.</u> Direct hits upon wheels. 6^{1} diameter holes blasted - no effect upon inner wheels.

e. Hit scored one inch below upper edges of side skirt. While the deck plating served to add thickness at the point of contact, a complete penetration was made, the hole being of sufficient diameter at its smallest point to allow an ordinary pencil to pass completely into the interior.

f. A hit upon the bolt holding two adjacent track plates together. The head of the bolt was sheared away completely, though the track plates were not damaged. It is possible that the bolt could have worked out, thus severing the track.

g. A hit upon the corner of the turret, making a <u>complete</u> penetration. The hole was cylindrical, 3/4" in diameter, with little flaking or enlargement on the inner surface. The blast effect was evident on the inside by the particles of steel having ricocheted from one side to the other.

h. A turret hit making a similiar $3/4^{\circ}$ hole with flaking on the inner surface of about 4° in diameter around the hole. There were approximately 36 small craters on the inner surface of the opposite turret armor, each at least $1/16^{\circ}$ deep and from $1/8^{\circ} - 3/8^{\circ}$ in diameter. As the face of each pit was smooth, the blast effect of the flying particles must be terrific. The area covered by these craters was roughly $8^{\circ} - 10^{\circ}$ in diameter.

i. A hit upon the very bottom edge of the rear plate. The projectile just grazed the armor and only a small nick was chipped out of the armor. The projectile did detonate, but the effect was underneath the tank in the ground.

j. A hit upon the towing-jack device on the rear of the tank. A small portion was chipped awy, but there was no effect upon the armor plate.

k. A hit upon one of the exhaust pipes, completely blasting it away, but there was no effect upon the armor plate inasmuch as the blast had been dissipated upon the exhaust pipe.

1. A ricochet off the rear armor, detonating in the ground.

m. & n. Two hits in the rear armor, each making a clean penetration, the hole being 1/2" in diameter through armor plate 2" thick.

o. A hit upon the lower portion of the front armor plate. No penetration was made. A 1-1/2" long gash, 1/2" deep, and 1/4" wide was gouged away.

p. A hit upon the towing hook on the front of the tank. No damaging effect upon the armor plate.

The bazooka will penetrate the armor on the side, rear, and side of the turret on the German Mk V Panther tank. The turret is very effectively penetrated and the blasted particles on the inside most certainly are lethal. The side armor is of less thickness than the turret and can be penetrated more easily.

The wheels and tracks are not profitable targets. Pieces may be blown out of the wheels or tires cut, but the possibility of stopping the tank is remote.

The rear armor is a profitable target, because the engine compartment is very susceptible to fire, even though the tool boxes, jacks and exhausts reduce the area of vulnerability.

Upon the front armor, it is difficult to get an effective burst, as the slope of the armor will ricochet the rocket. No perpendicular hits were obtained during the trial.
